MINISTERUL TRANSPORTURILOR ȘI INFRASTRUCTURII
AGENȚIA DE INVESTIGARE FEROVIARĂ ROMÂNĂ - AGIFER

**ROMANIAN RAILWAY INVESTIGATION
AGENCY
- AGIFER -**

**ANNUAL REPORT
2024**

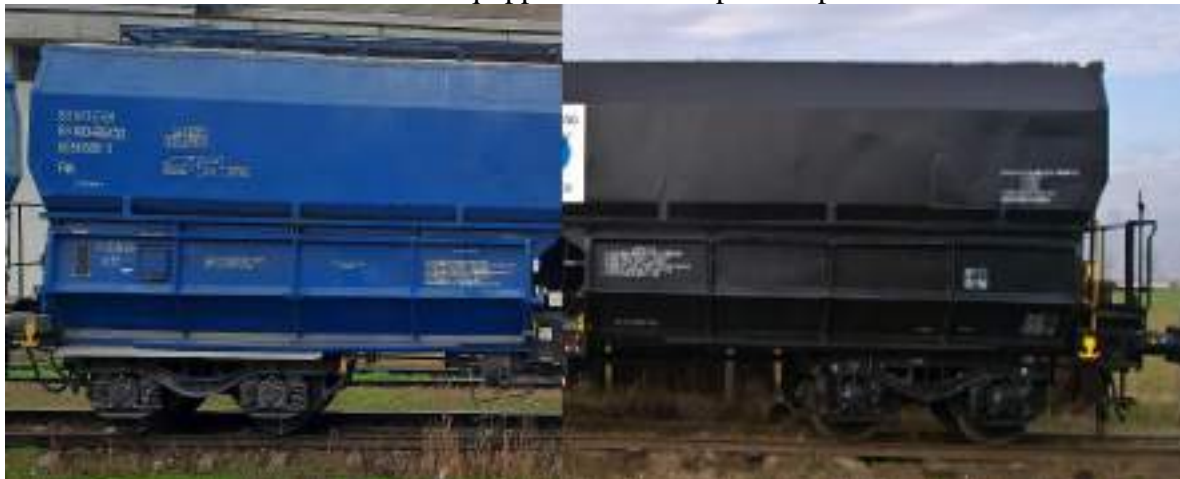
The additional fixed downgrade extension was carried out by installing a 3200 mm x 240 mm metal plate in the area of the bogies, which significantly obstructs access to the side bearers for checking allowances, as required by Instruction no. 250 (see photo no. 9 and photo no. 10).

This configuration makes it impossible for the operating personnel to check the side bearer allowances according to Instruction no. 250, except for a rough visual approximation. It is worth noting that actual measurements of the side bearer allowances were performed by two persons at Vlădeni railway station during wagon weighing, while at SC Electroputere VFU SA Pașcani the checks were carried out on a track equipped with an inspection pit.

Photo no. 9 – Fals series wagon with fixed downgrade (bottom) compared with standard Fals series wagon (top).

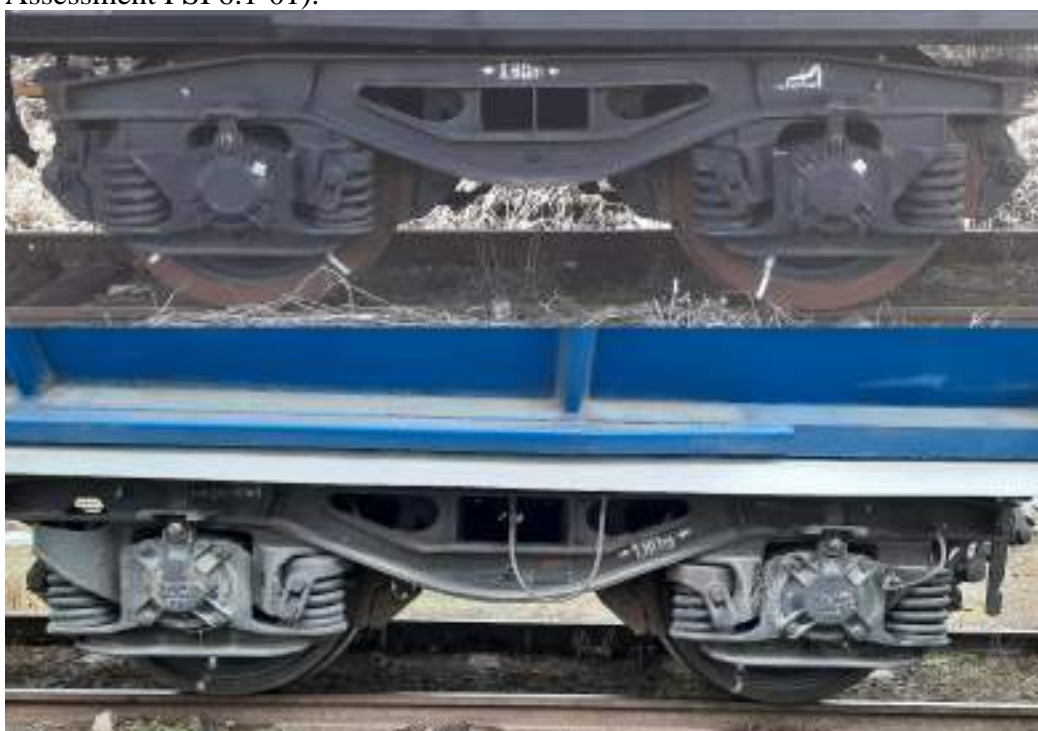
Although the operating staff (carriage and wagon inspectors) acknowledged that side bearer allowances are only visually estimated on these wagons, there was no in-service monitoring program or analysis, as required by the railway undertaking's procedures (Operational Procedure Management of the Train Inspection Process PO 8.1-01 and Integrated System Procedure Risk Assessment PSI 6.1-01).

Photo no. 10 – Comparative view of access to the side bearers: standard Fals series wagon (top) vs. Fals wagon with fixed downgrade (bottom).
