MINISTERUL TRANSPORTURILOR ȘI INFRASTRUCTURII
AGENȚIA DE INVESTIGARE FERROVIARĂ ROMÂNĂ - AGIFER

ROMANIAN RAILWAY INVESTIGATION AGENCY - AGIFER - ANNUAL REPORT

2020

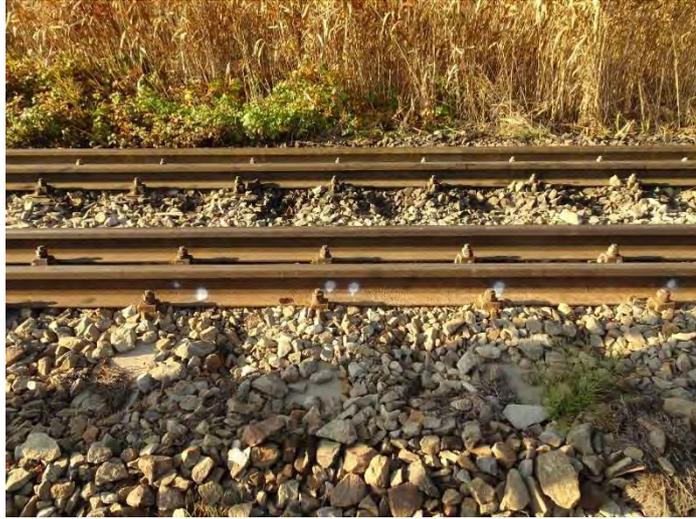
photo no.18

- on the walked distance, the superstructure of the mixed track consisted in rails type 49 fitted on the reinforced concrete sleepers type T19A, non-welded track;
- the head of District no.4 Dornești had made an inventory of the sleepers, the improper sleepers to be replaced of emergency I and II being marked properly on the common-crossing of the rail, right rails (in the direction of the track km) (photo no.18);

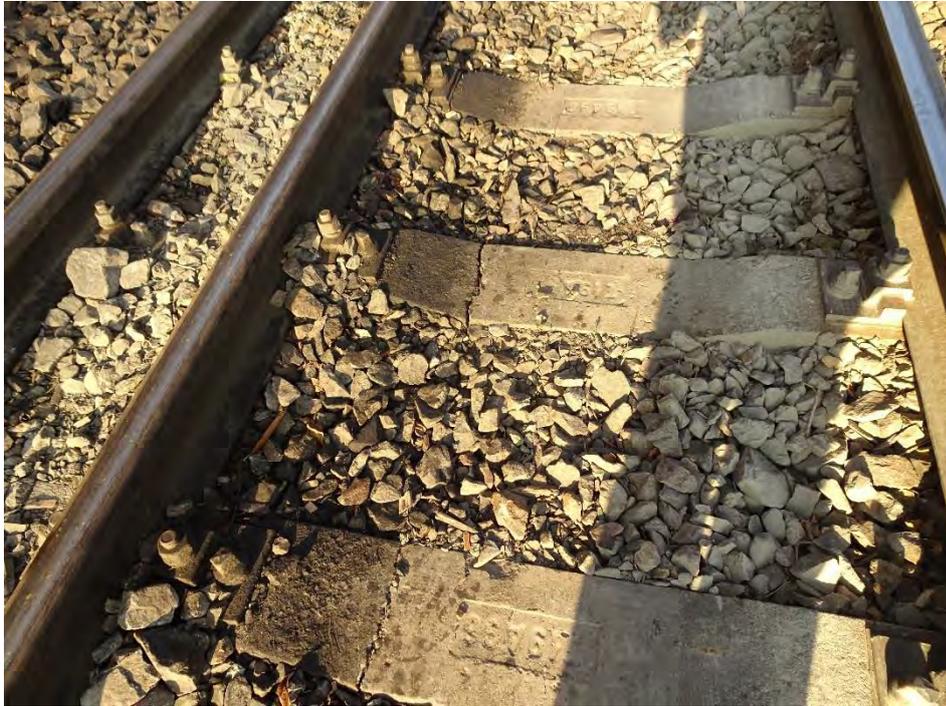
photo no.19

- concrete sleepers T19 A with transversal cracks close to the block (photo no.19);

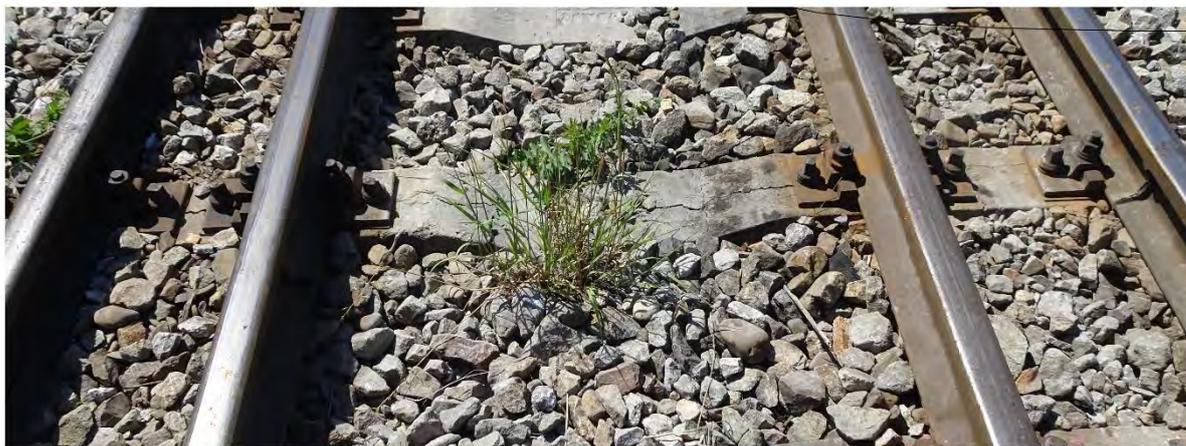
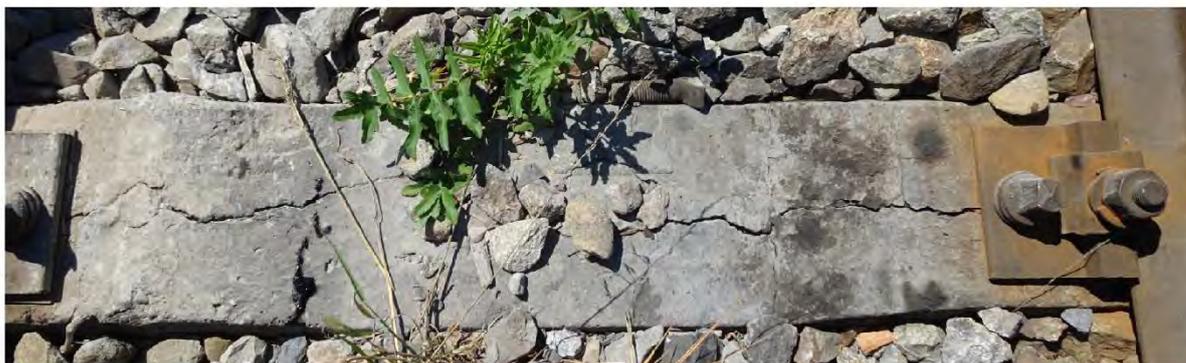
photo no. 20

- concrete sleepers T19 A within the track length with longitudinal cracks (photo no.20);

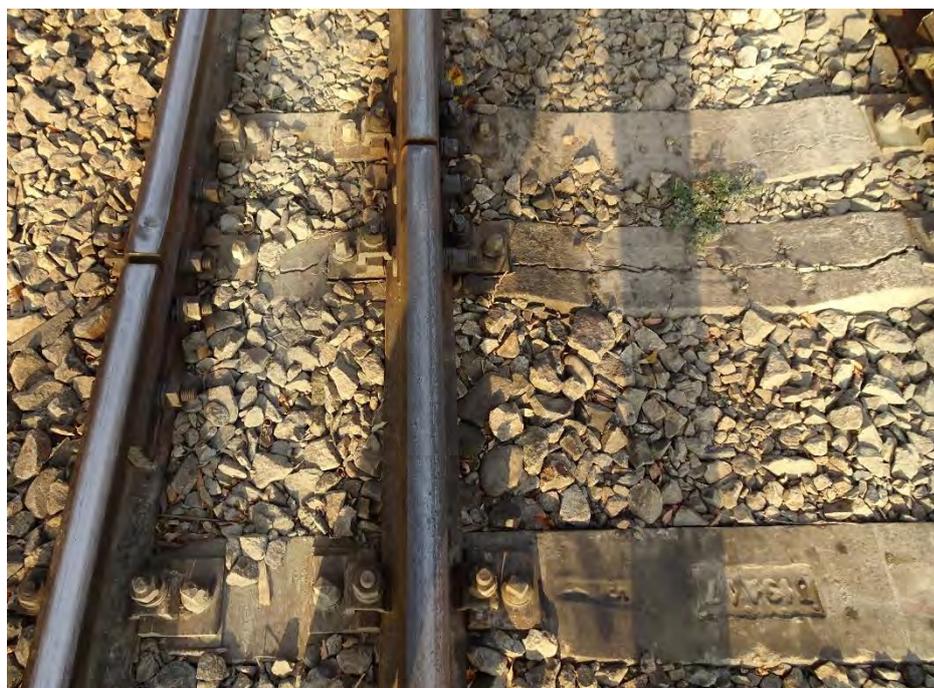
photo no.21

- joints that do not meet with the instruction, without special sleepers for joints. Because of it, in some situations the metallic plates cannot be fitted, or if these can be fitted, then it is not possible the fastening of the rail bases using clips type K, following the position of the horizontal screws for the fastening of the joint fish plates. All of these generate the destruction of the sleepers from the joints (photos no.21, 22);

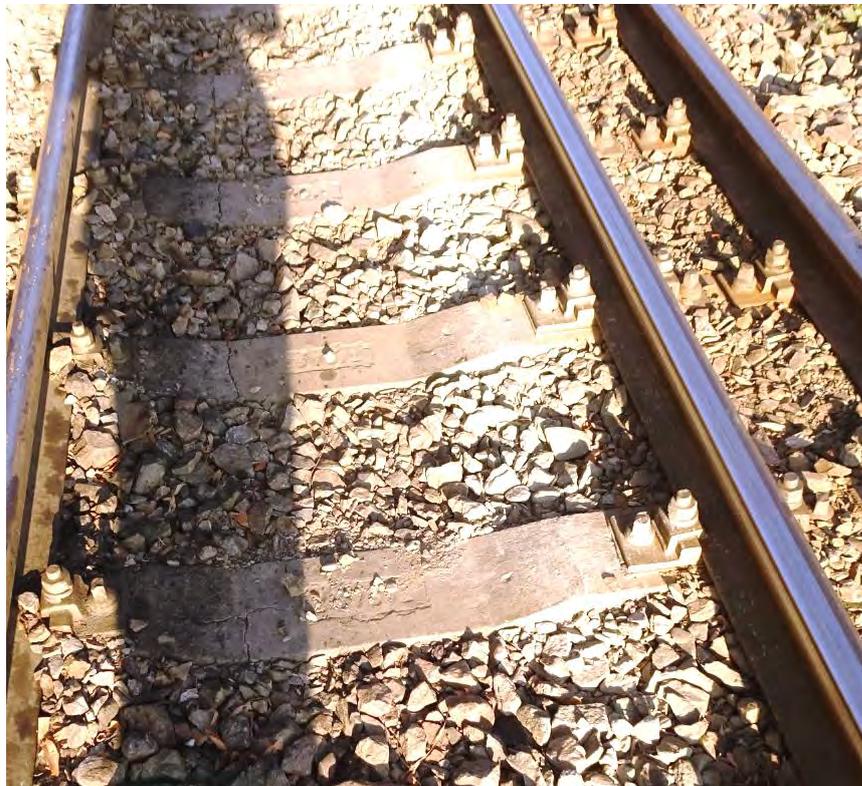
photo no. 23

- consecutive sleepers with cracks and ruptures (photo no.23).
