ROMANIAN RAILWAY INVESTIGATION  
AGENCY  
- AGIFER -

ANNUAL REPORT

2022

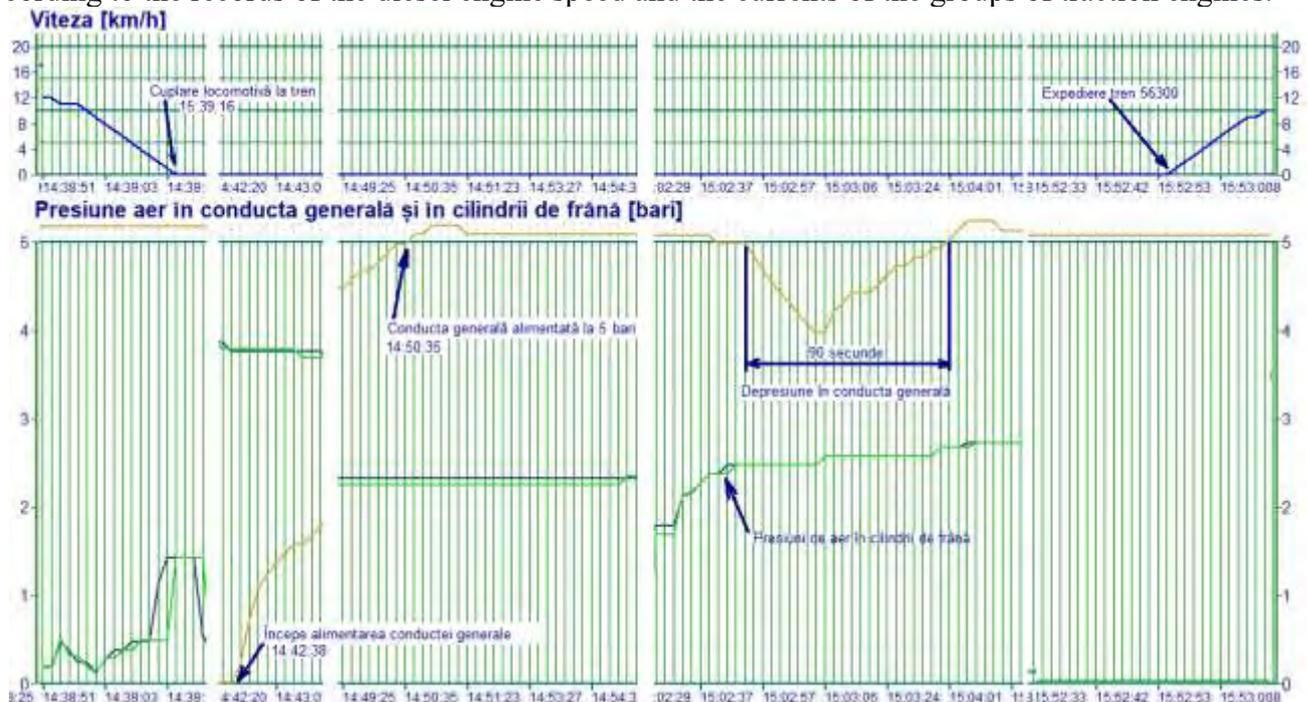
Figure no.5 - Air pressure into the general pipe and into the brake cylinders in the railway station Crivina.

Likewise, the slight increases of the pressure into the brake cylinder are due to some air losses at the triple valve of the locomotive and these pressures were removed periodically by the operation of the release valve by the driver. The investigation commission concluded the effectiveness of the automatic brake was not tested after the dispatching of the train 56300-1.

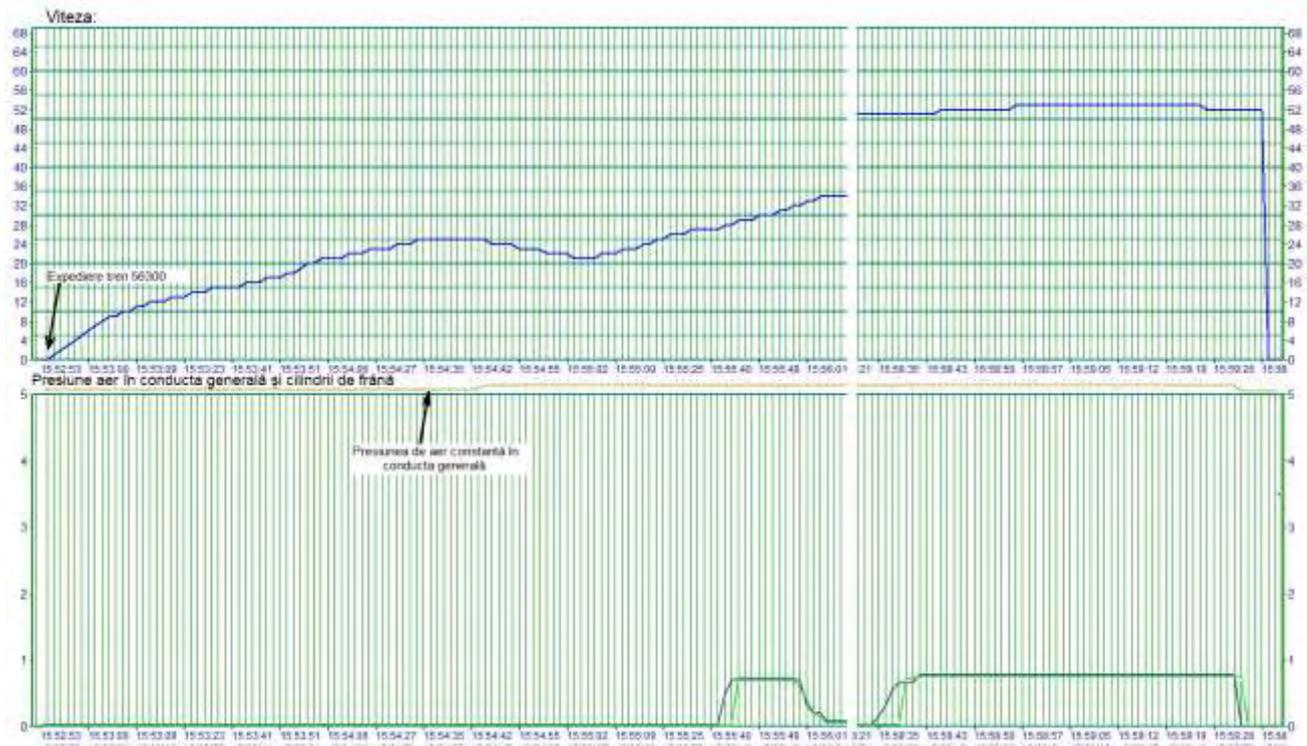
Figure no.6 – Air pressures into the general pipe and into the brake cylinders after the dispatching of the freight train no.56300-1 from the railway station Crivina.
