# ROMANIAN RAILWAY INVESTIGATION AGENCY - AGIFER -

## ANNUAL REPORT 2025

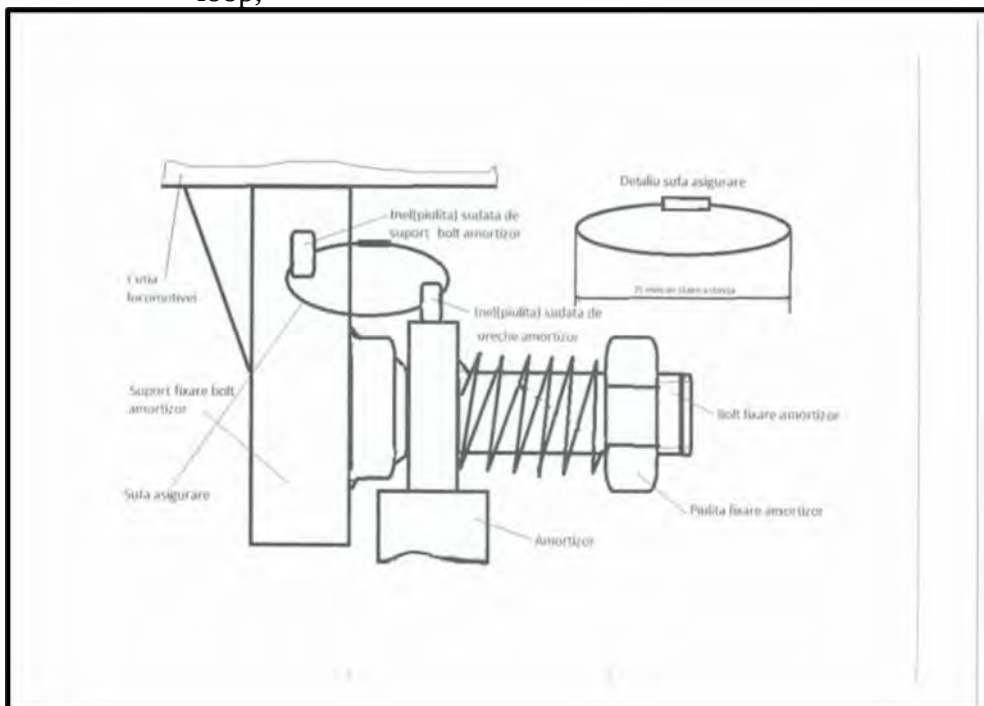
- On 9th October 2024, from the SC Service of SNTFC “CFR Călători” SA, the technical proposal by which the securing against falling of the dampers could be achieved following the breaking of their upper fastenings was transmitted to the Rolling Stock Headquarters of the same operator, as follows:

- Mounting by welding, on each upper support (on the locomotive body) for fixing the pin of the vertical dampers, of one metal ring (nut);
- Mounting by welding, on the upper part, on each fixing lug of the vertical damper, of one metal ring (nut);
- Mounting between the two metal rings (nuts) of a securing cable in the form of a loop;

This technical proposal was taken into consideration and, after the date of issue, put into practice as follows:

- On 13th November 2024, from the Rolling Stock Headquarters of SNTFC “CFR Călători” SA, document no. SIRM/8/833/13.11.2024 regarding the technical solution for securing the dampers on Co-Co type electric locomotives, proposed by the SC Service, was transmitted to all Passenger Railway Transport Regional Branches 1-8, including SCRL Brașov, for implementation;
- On 28th April 2025, from the Rolling Stock Headquarters – Rolling Stock Maintenance and Repair Service of SNTFC “CFR Călători” SA, the document without number regarding the technical solution for securing the dampers on Bo-Bo type electric locomotives, proposed by the SC Service, was transmitted to the Passenger Railway Transport Regional Branches Craiova, Timișoara, Iași and Galați, including SCRL Brașov, for implementation.
