**INTERIM STATEMENT**  
**about the railway accident happened on 19<sup>th</sup> February 2025**  
**in the railway station Mihăești**

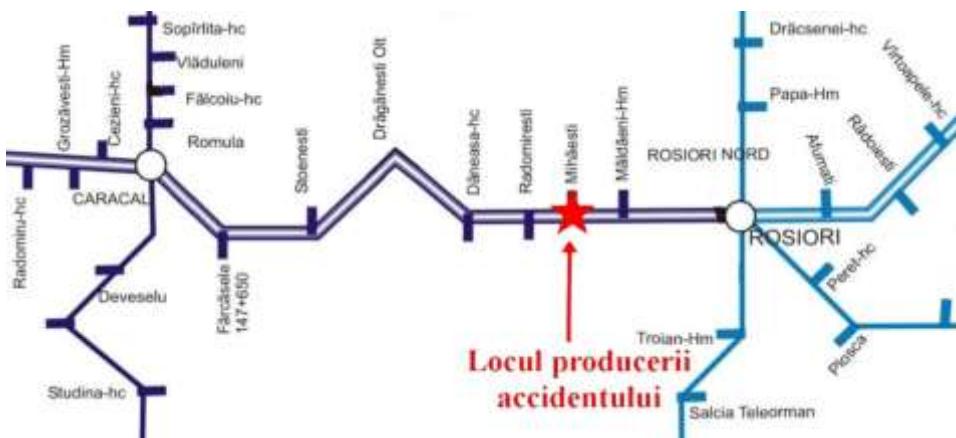
On 19<sup>th</sup> February 2025, at about 10:42 o'clock, in the railway county Craiova, on the track section Roșiori Nord – Caracal (electrified double-track line), at the exit of the railway station Mihăești, on track I (at the Y end – the area of the switches no. 10–12), the derailment of four wagons from the composition of freight train no. 57306, got by the railway undertaking Rail Cargo Carrier România SRL, occurred. As a consequence of the derailment, the 17<sup>th</sup> wagon of this train collided with locomotive ES 008, which was hauling freight train no. 58572, running in the opposite direction, on track II.

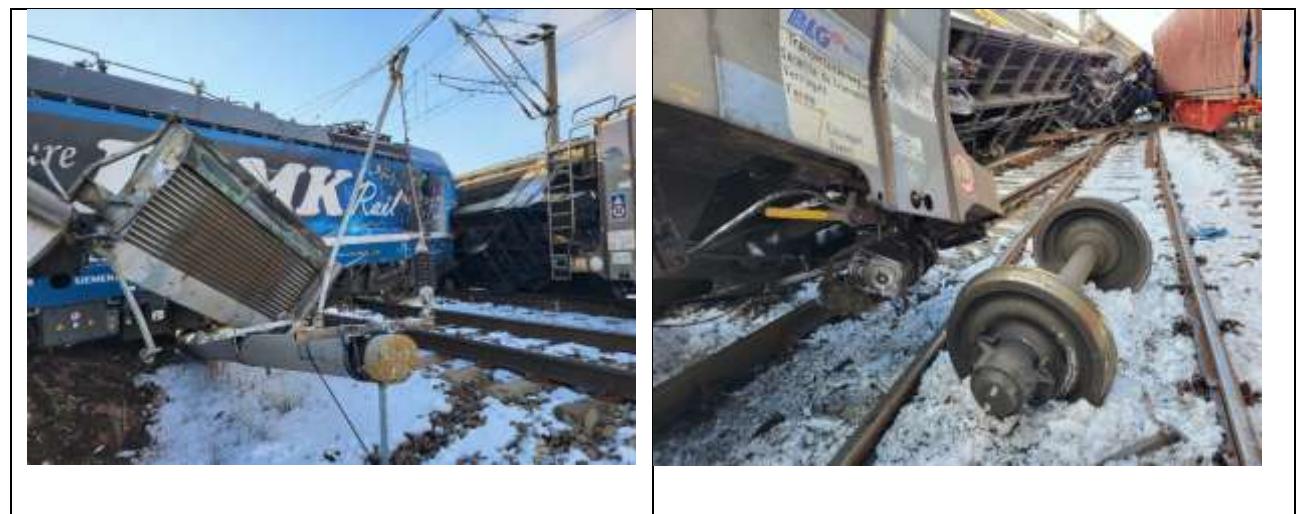
As a consequence of the accident, four concrete poles supporting the overhead contact line (no. 75, 76, 81 and 83) were affected, and the overhead contact line between SCB 77 and SCB 85, as well as between SCB 74 and SCB 82, was broken and fell to the ground.
