**ROMANIAN RAILWAY
INVESTIGATION AGENCY
- AGIFER -**

**ANNUAL REPORT
2017**

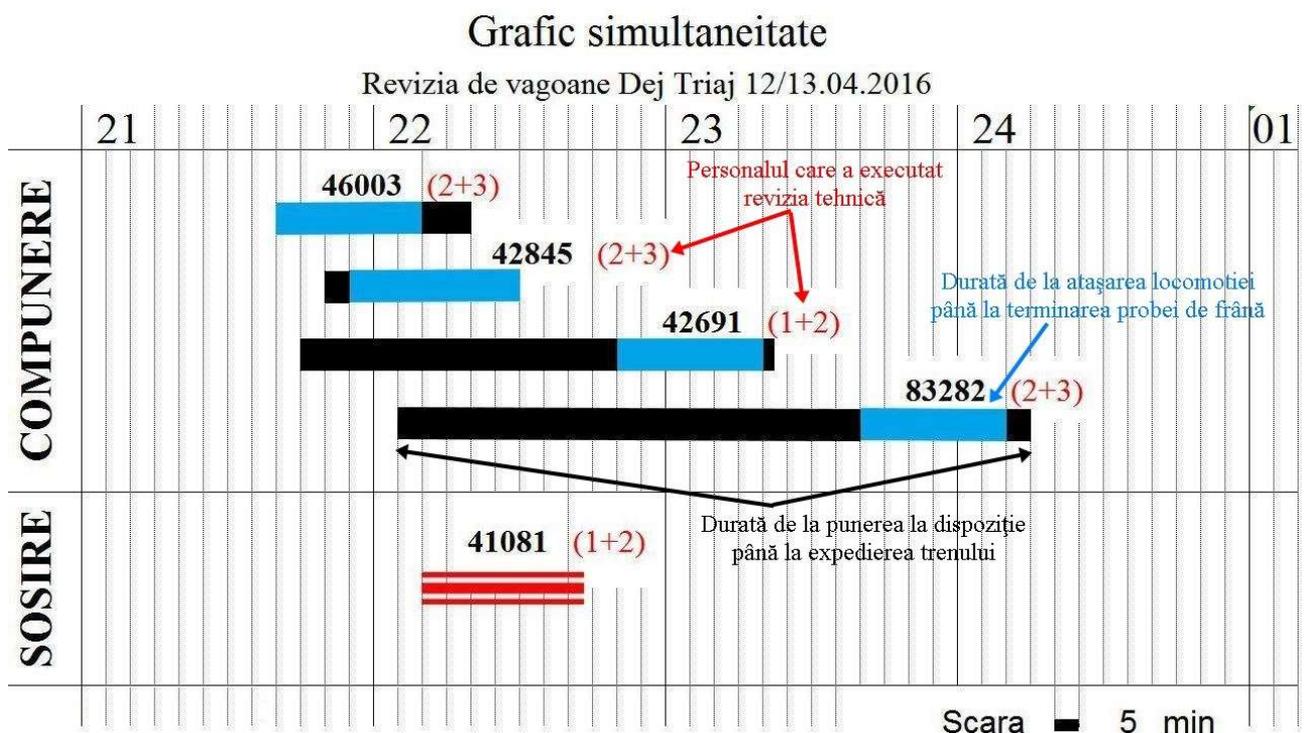
- in the Wagon Inspection Point Dej Triaj, within the shift from the 12th/13th of April 2016 there were present on duty 1 shift head (authorized to perform the tasks of the examiner) and 2 examiners. This staff between the hours 21:40 ÷ 00:15 had to perform the technical inspection 4 trains, stipulated with technical inspection during the forming and 1 train with technical inspection at its arrival. As one can see in the simultaneity chart this staff had to perform simultaneously the technical inspection at a lot of trains, the highest work load being for the examiner mentioned in the register „Inspected trains” position no.2.

With reference to the accident happened in the running of the freight train no.42619, one found out that the braking beam of the wagon no.31533556277-5 detached and fell because keeping in traffic of this wagon with failures at the brake rigging, that can generate the fall of its parts.
